Wirral MBC
Flood Investigation
Report
Reeds Lane/Reedville
Grove, Leasowe

1 Introduction

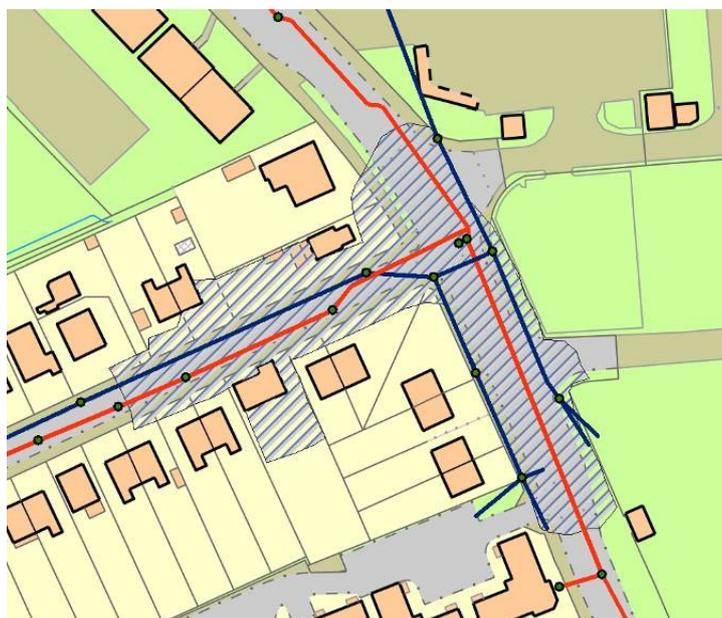
Fig.2. Approximate extent of the flood, Reedville Grove/Reeds Lane.

Rain started to fall around 6.00pm on Sunday the 23rd September, it continued overnight and through the following day, stopping at around 5.00pm on the 24th. At approximately 12.00pm on the 24th Reeds Lane and Reedville Grove started to flood and by 2.00pm Reeds Lane became difficult to drive through to the extent that Bristol-Myers Squibb started to clear their site of cars, fearing that they may not be able to remove them later. At 4.00pm the Council received requests to provide sandbags to defend domestic properties and a decision was made by the Emergency Control Operators to issue sandbags although this was contrary to the Council's sandbag policy; and by 6.00pm Reeds Lane was closed. United Utilities were on site by 5.00pm on the 24th and started removing the flood water into tankers. Flood water was surcharging from manholes on the public combined sewer system. The public surface water sewer system also surcharged and was unable to drain the floodwater through the gulleys in the road. High river levels on the Birket are believed to have prevented efficient discharge from the public surface water system at the flapped outfall. One property suffered some flooding to its garage/workshop and porch; and nine properties suffered flooding to their gardens and driveways, while access to Bristol-Myers Squibb Pharmaceuticals was also restricted. UU continued to pump until late in the evening but were requested to stop due to noise. The Environment Agency attended the site at 9.30pm, following reports of flooding in Reedville Grove and high river levels on the Birket. UU continued to draw off the flood water throughout Tuesday the 25th and into Wednesday 26th. Rain started again on Tuesday afternoon and continued, albeit with a lesser intensity until Wednesday morning. Bristol-Myers Squibb Pharmaceuticals remained closed on Tuesday 25th. On Wednesday 26th both United Utilities and the Council's Emergency Planning Team responded to the access problems that the flooding was causing by utilising vehicles, which included a 4x4, to assist residents to move through the flood water. The Emergency Planning Team also arranged for a Social Services Team to be on site to assist vulnerable people to access medical assistance and undertake some shopping for essential groceries. The Fire Brigade were also in attendance and assisted residents and care workers through the floodwater until the 4x4 vehicle arrived on site. On Wednesday the combined sewer manhole was still surcharging but floodwater started to slowly drain into the surface water system and into the Birket. Bristol-Myers Squibb re-opened on Wednesday and workers were helped into the factory, borrowing wellington boots to get through the flood water, their cars were parked on Reeds Lane. By Thursday morning, the 27th, the majority of the flood water had subsided, although water was still surcharging from the public combined sewer in Reedville Grove and running away down the nearby road gulleys. Following a hose down of the area and gully cleaning by United Utilities the Road was inspected and re-opened. Damage to Reedville Grove footway and kerbing was identified and emergency works ordered. It is not known at this stage, if any long term damage has occurred to the Public Highway

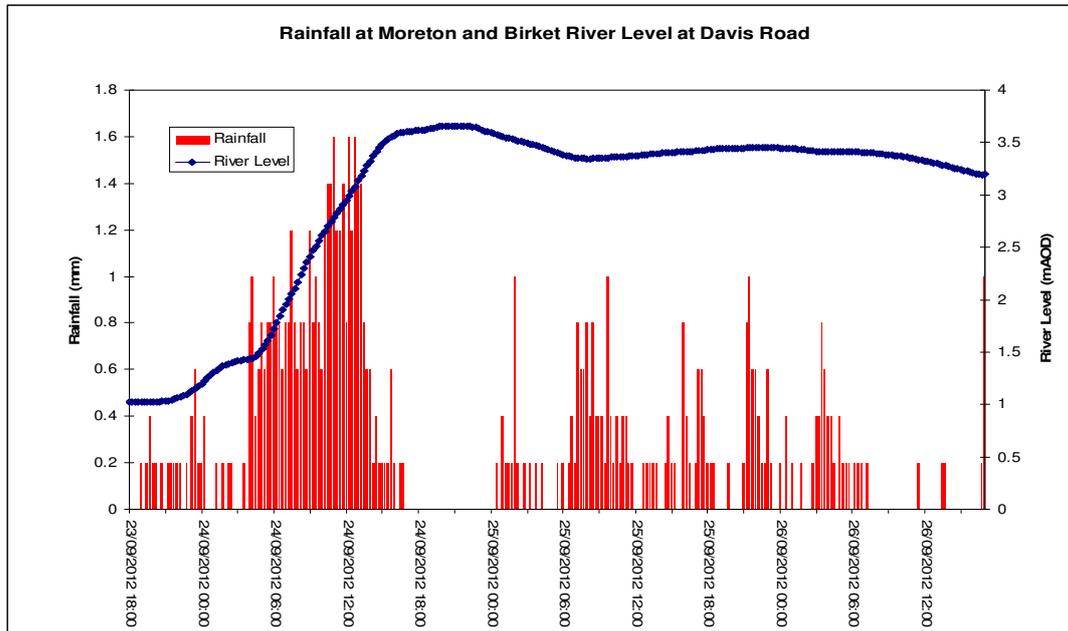
Fig.3. Rainfall and river levels.

The summer of 2012 was one of the wettest on record with over 150% of normal rainfall. September continued to be wet and maintained the saturated ground conditions. Rainfall falling on saturated ground has little chance of infiltration and consequently the rain ran-off quickly into the rivers and sewer networks. On the 23rd September rain started to fall at about 6.00pm and continued through the night and the following day, when Reeds Lane/Reedville Grove started to flood. Despite a brief respite on the evening of the 24th rain started again in the early hours of the 25th and continued most of the day; albeit at a lower intensity. The graph below shows the rainfall recorded at Moreton rain gauge and the river levels on the Birket at Davis Road close to the entrance to the Great Culvert. The rain gauge at Moreton recorded nearly 70mm in 48 hours and over 75mm in 60 hours. This amount of rainfall has a probability of occurring approximately every 20 to 25 years, or in other words, a 4% to 5% probability of occurring in any one year. The rainfall was caused by a very slow moving depression centred and circulating around the middle of England.

The rainfall during the 23rd to 26th of September fell on saturated ground and rapidly ran-off into the river system forcing the levels to rise quickly, rain fell over three days, off and on, and maintained the rivers at a high level for several days. The river height came up to within about 1m of the bank top in the area close to the Debris Screen at the Great Culvert Entrance and level monitoring gauge at Davis Road but still had a great deal of capacity in the channel. There are three major elements of infrastructure affecting the Birket, a recently upgraded debris screen at the entrance to the Great Culvert, a pumping station operated by United Utilities that intercepts the River Birket flows and pumps them into the West Float Docks, the pass forward flows, particularly during storm conditions then combine with discharges from the surrounding public sewers and pass to a further pumping station which lifts the flows to the United Utilities Shore Road treatment works on the River Mersey. During the period of the flooding, the debris screen was in operation and both the pumping stations were reported to be running at their maximum capacity. Although none of the flooding in Reeds Lane area was due to the Birket overtopping its banks, the continued high levels prevented the discharge of the flooding for an extended period.

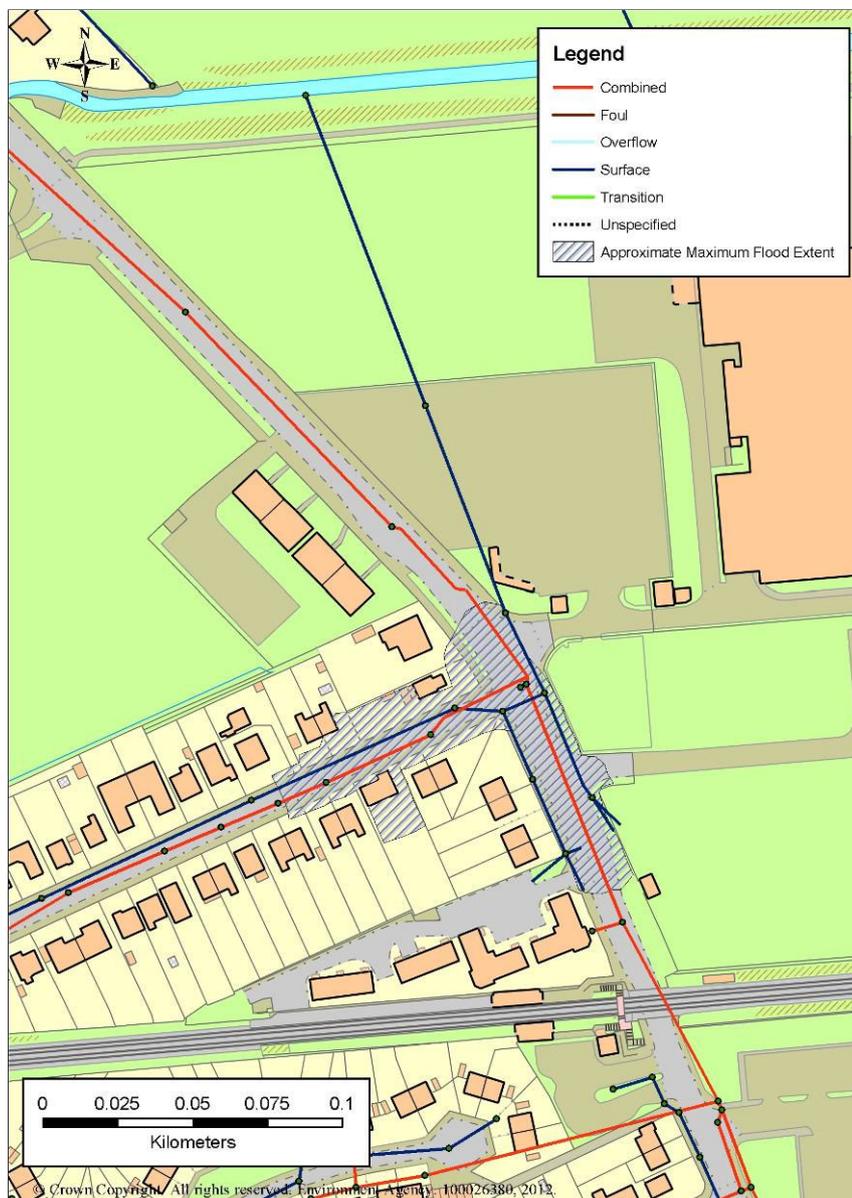
Fig.6 United Utilities sewer network and approximate flood outline.

The area is presently drained via a public combined and surface water drainage system. The combined sewers drain to a pumping station located close to the Moreton Driving Range at Tarran Way South and are then pumped to the United Utilities waste water treatment works at Moreton, while the surface water system, which takes run-off from the public highway, flows generally north for about 250 metres before discharging into the Birket via a flapped outfall. The combined and surface water sewer networks are the responsibility of United Utilities. The combined sewer accepts both foul and some surface water drainage.

The flooding on Reeds Lane and Reedville Grove was caused by a combination of flows from the surcharged combined sewer in Reedville Grove and surface water which was unable to discharge to the separate surface water sewer through the road gullies due to high river levels that prevented free discharge at the surface water sewer outfall into the Birket. The flood water level at the low point in the road was at a similar level to the peak water level of the Birket at the outfall and over the period of flooding the river level remained fairly constant. The road started to drain when the river level had dropped sufficiently to allow the flap valve at the outfall to open.

- United Utilities should check the functionality of the flapped outlet from the surface water sewer into the Birket.
- The Environment Agency together with United Utilities and Wirral Borough Council should consider whether there are any viable options to minimise river locking of the surface water outfalls into the Birket.

- United Utilities should review the performance of their assets/infrastructure during the event and consider any viable options to reduce the surcharging of the system at this low point.

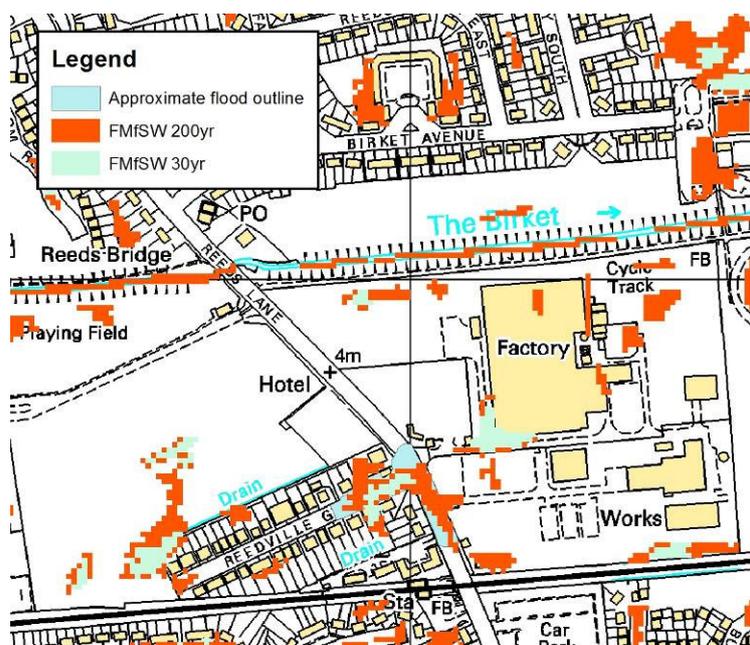
Fig.7. Environment Agency flood outline maps

The water being unable to drain from either system inundated the road and gardens and eventually caused some internal flooding in one property. The area that flooded is in a low point and has been identified as an area susceptible to surface water flooding on the Environment Agency's Flood Map for Surface Water. (Fig 7)
